Manhole Inspection Summary

Manhole # S15M__002MH

Insp Date: **3/11/08 12:27 PM**

Location Address: **2657 frederick av**

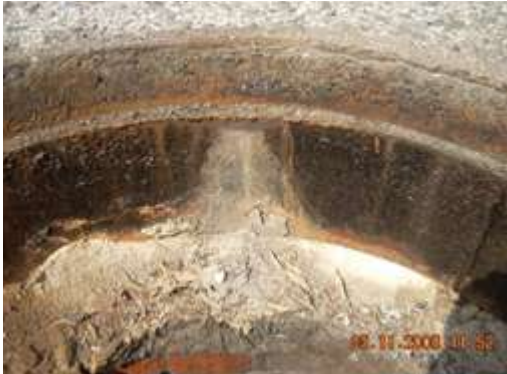
Misc

inflow evidence

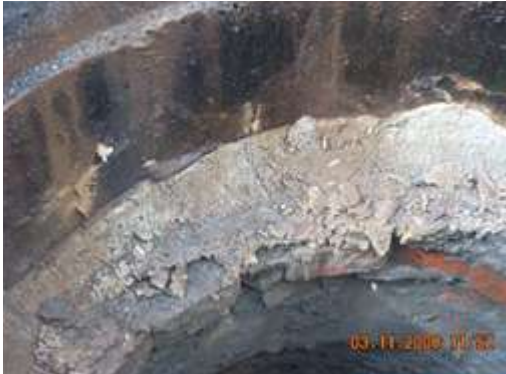
Defect 1

Frame Offset: **3** (in.) Condition: ☒ Sound ☐ Cracked ☐ Leaks

frame offset

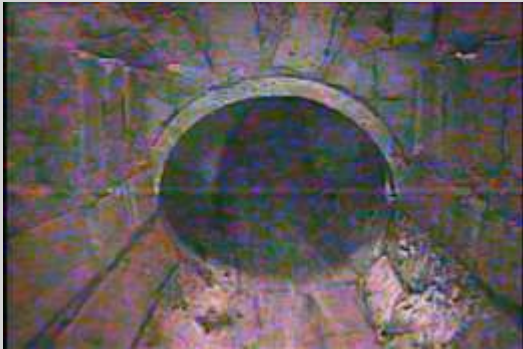
12 O'Clock Outflow

10 in. Circular Gravity Sewer
Pipe Out @ 12 O'Clock

Pipe Height: **10.8** (in.) Rod and Bar (Angled)
Pipe Material: **Clay** ☐ Pipe Lined
Invert Depth: **11.37** (ft.) Flow Characteristics: **Fast**
Deposits: ☒ None ☐ Mud ☐ Sludge ☐ Debris ☐ Grease
Silt Depth: **0** (in.) Deposits Extent:
Infiltration: **None** Pipe Seal Cond: **Sound**

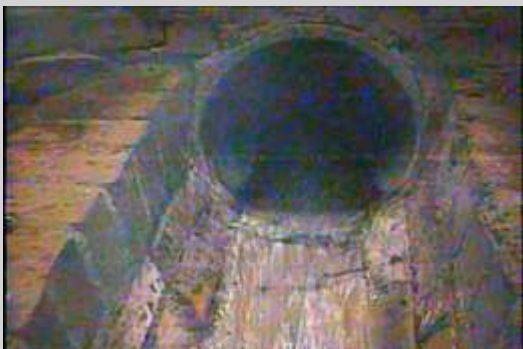
6 O'Clock Inflow

10 in. Circular Gravity Sewer
Pipe In @ 6 O'Clock

Pipe Height: **10.8** (in.) Rod and Bar (Angled)
Pipe Material: **Clay** ☐ Pipe Lined
Invert Depth: **10.22** (ft.) Flow Characteristics: **Fast**
Deposits: ☒ None ☐ Mud ☐ Sludge ☐ Debris ☐ Grease
Silt Depth: **0** (in.) Deposits Extent:
Infiltration: **None** Pipe Seal Cond: **Sound**
